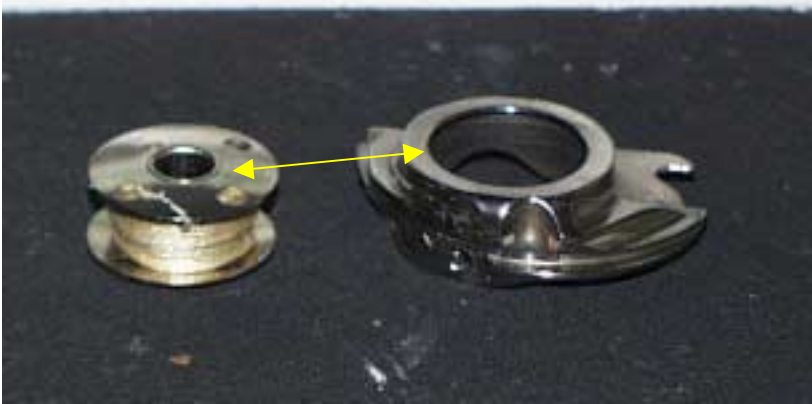
Typical bobbin and bobbin case, looking at the bottom of the bobbin case (above). Typical metal bobbin, top right. And typical bobbin and bobbin case, picture on the left.

When the top thread passes around the bobbin case, its been known for the top thread to catch the little ring that holds the metal bobbin together, on the underneath side, and cause jamming, and for the top thread to break.

Using the Singer 66 Class plastic bobbins will help eliminate this. After so many years of wear and tear, the inside of the bobbin case gets worn down, and the metal bobbins begin to ride lower in the bobbin case. Once this happens, that little metal ring will protrude below the bottom of the bobbin case. See picture at the top.
